LOOD PLAIN MANAGEMENT STUDY

MISTEGUAY CREEK GENESEE, SAGINAW AND SHIAWASSEE COUNTIES, MICHIGAN

OCTOBER 1989

**U.S. Department of Agriculture
Soil Conservation Service
East Lansing, Michigan**

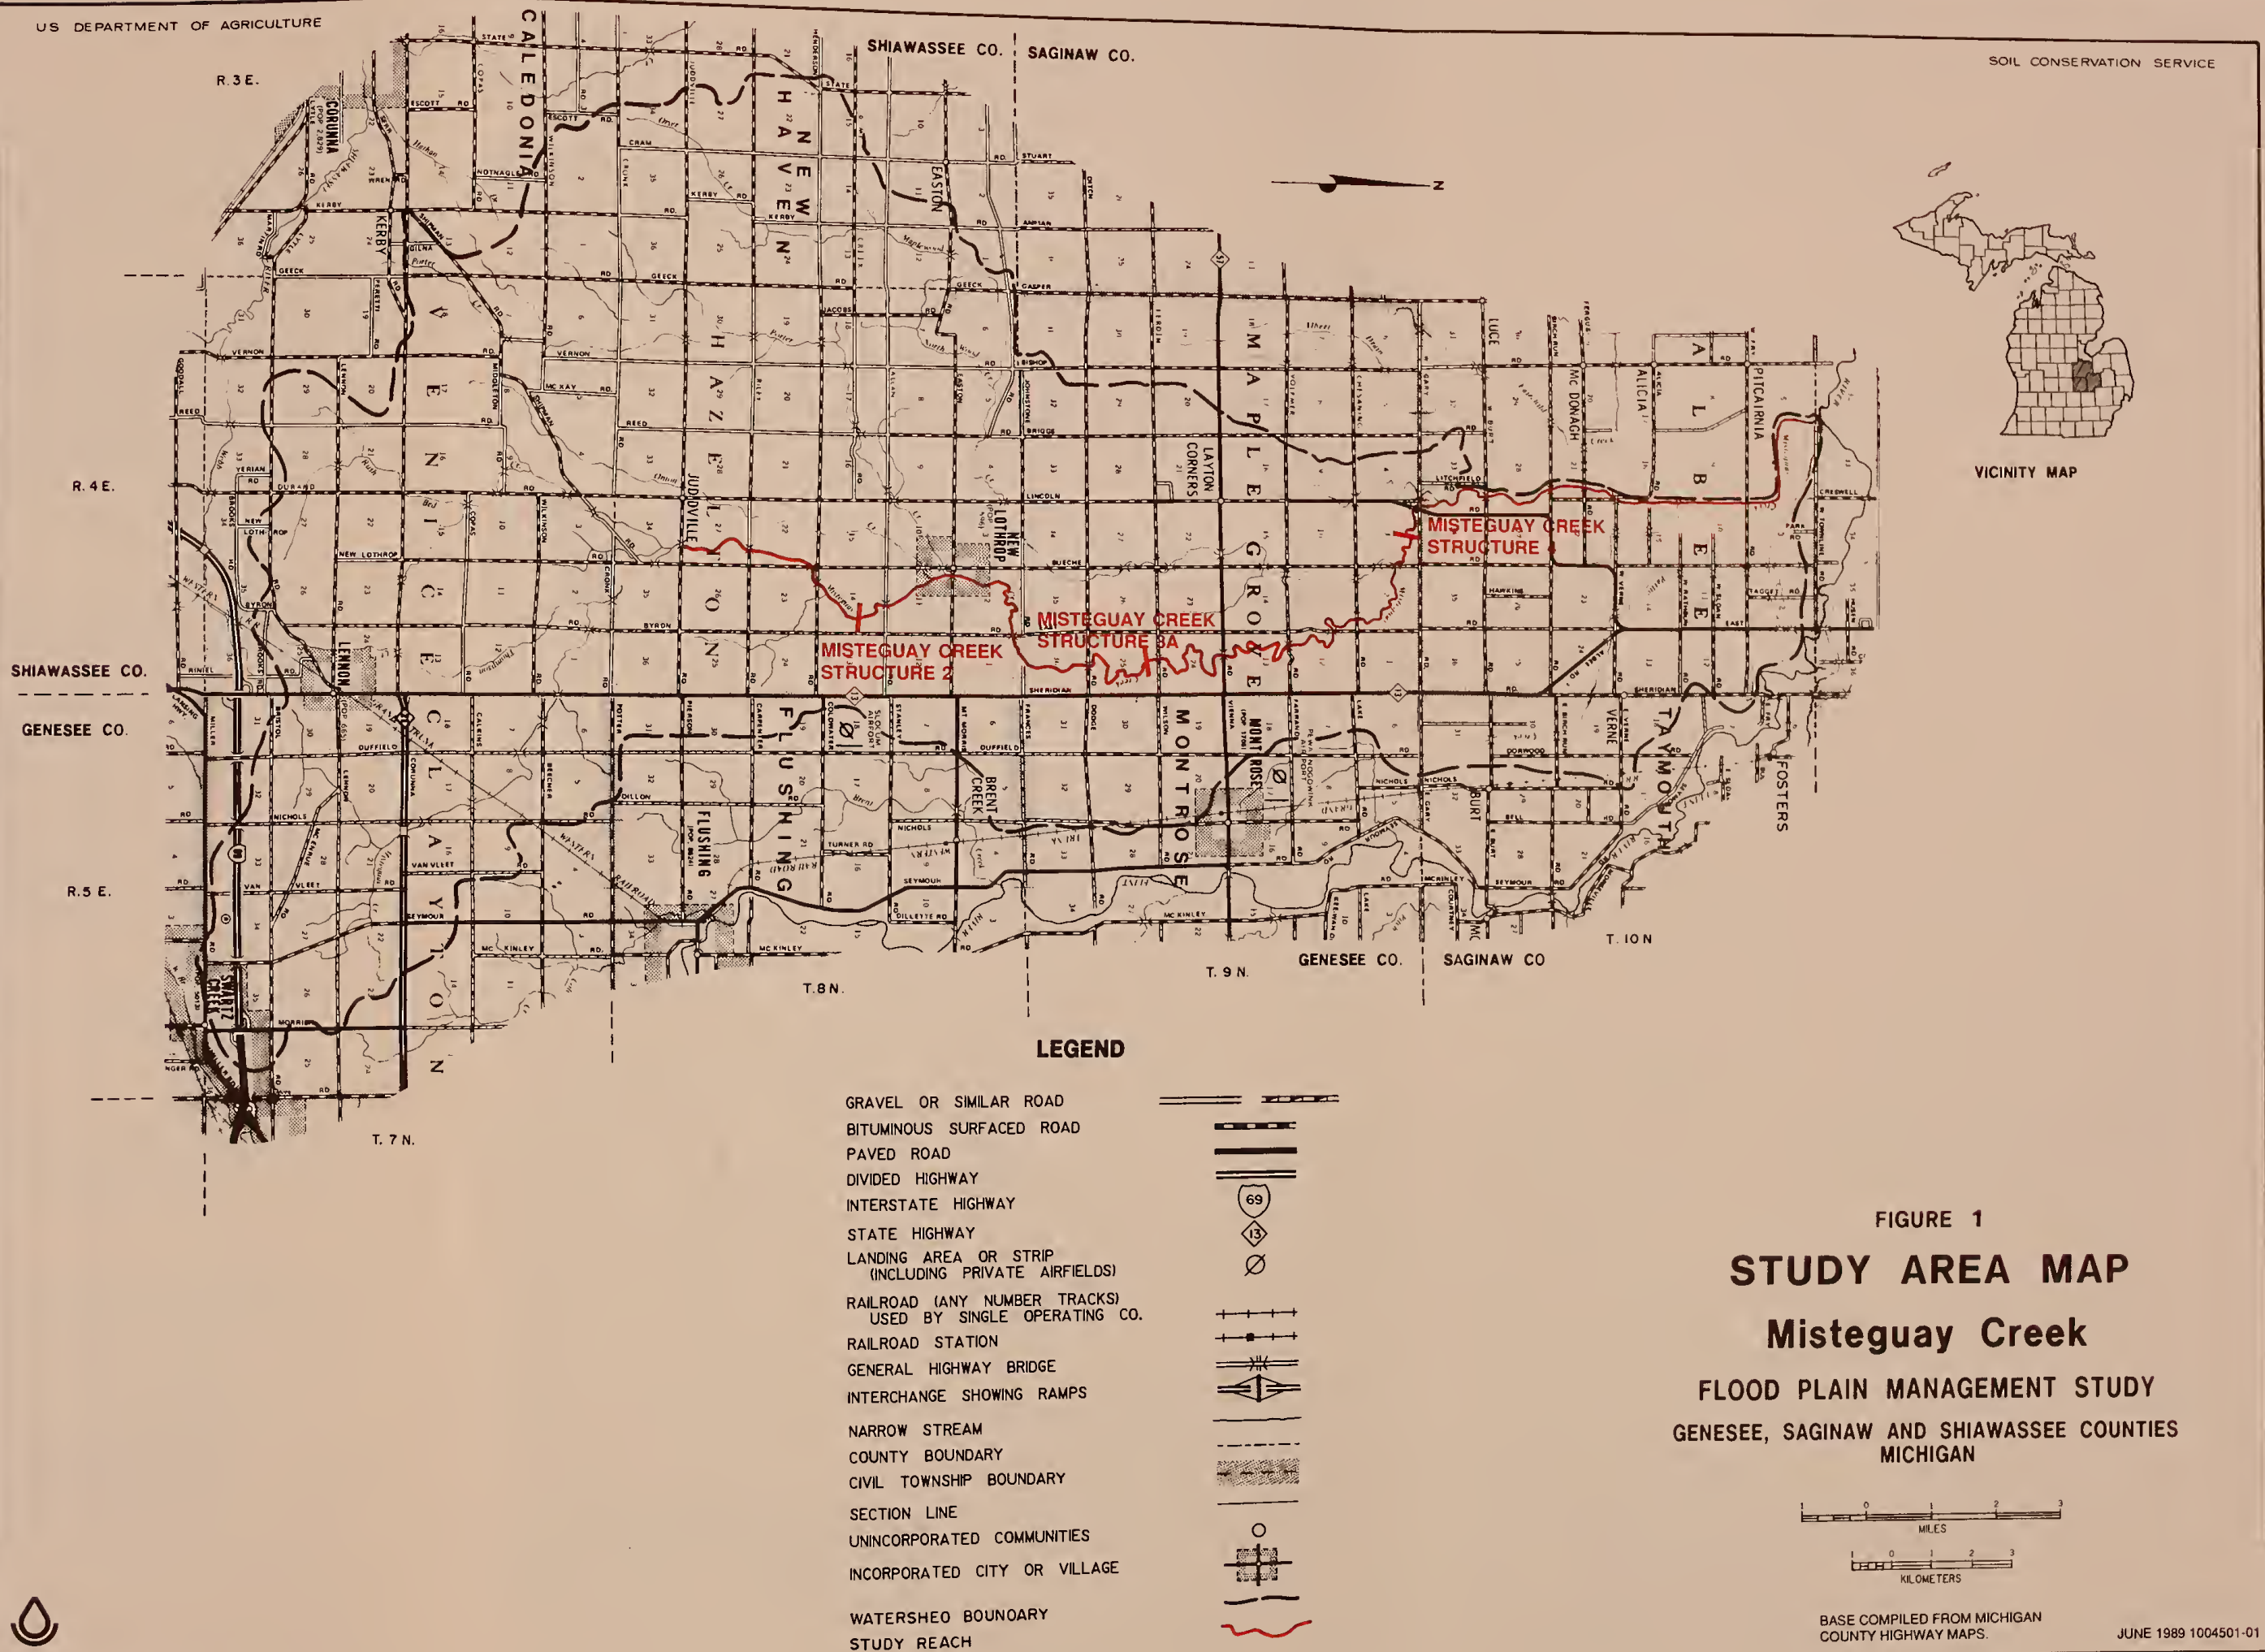
FIGURE 1

The study area is in Genesee, Saginaw and Shiawassee Counties. High water profiles and flood plain delineations were made along Misteguay Creek for a distance of about 28 miles. The study area is identified on Figure 1.

STUDY AREA MAP

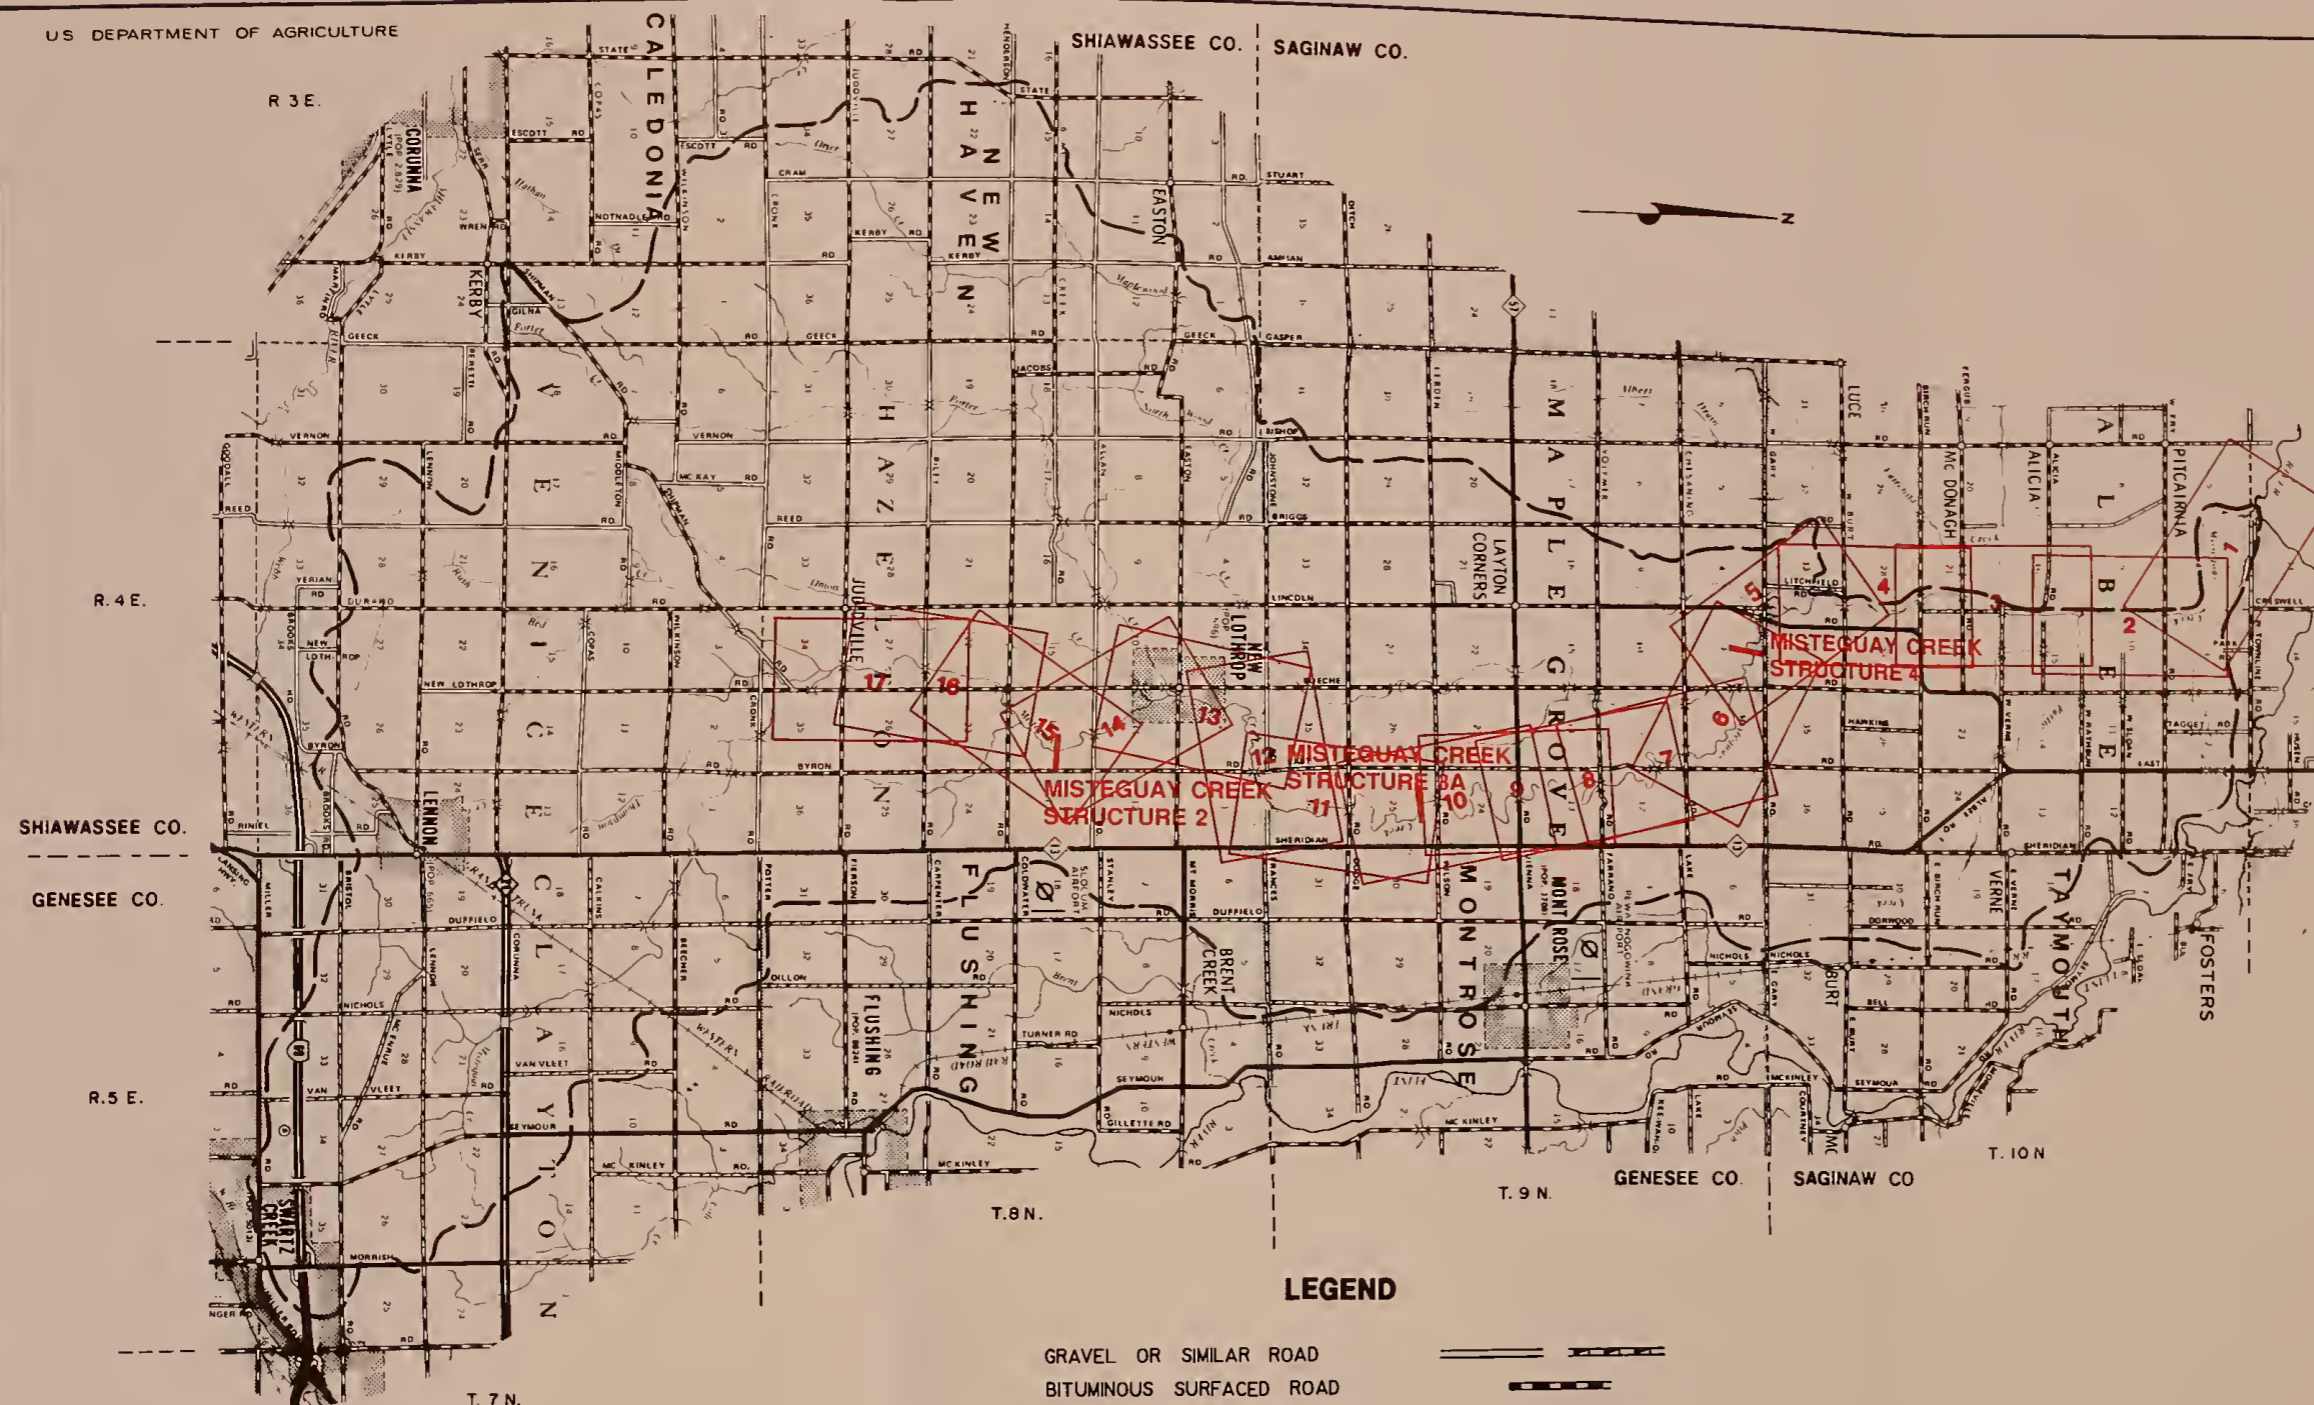
FIGURE 2
PHOTO SHEET INDEX MAP
Misteguay Creek
FLOOD PLAIN MANAGEMENT STUDY
GENESEE, SAGINAW AND SHIAWASSEE COUNTIES
MICHIGAN

To determine flood levels for a specific location, locate the area of concern on the sheet index, Figure 2 (Appendix A). Select the appropriate flood hazard photomap. Using this photomap, locate the area of concern on the map and its relationship to the nearest identification point (cross-section, road).

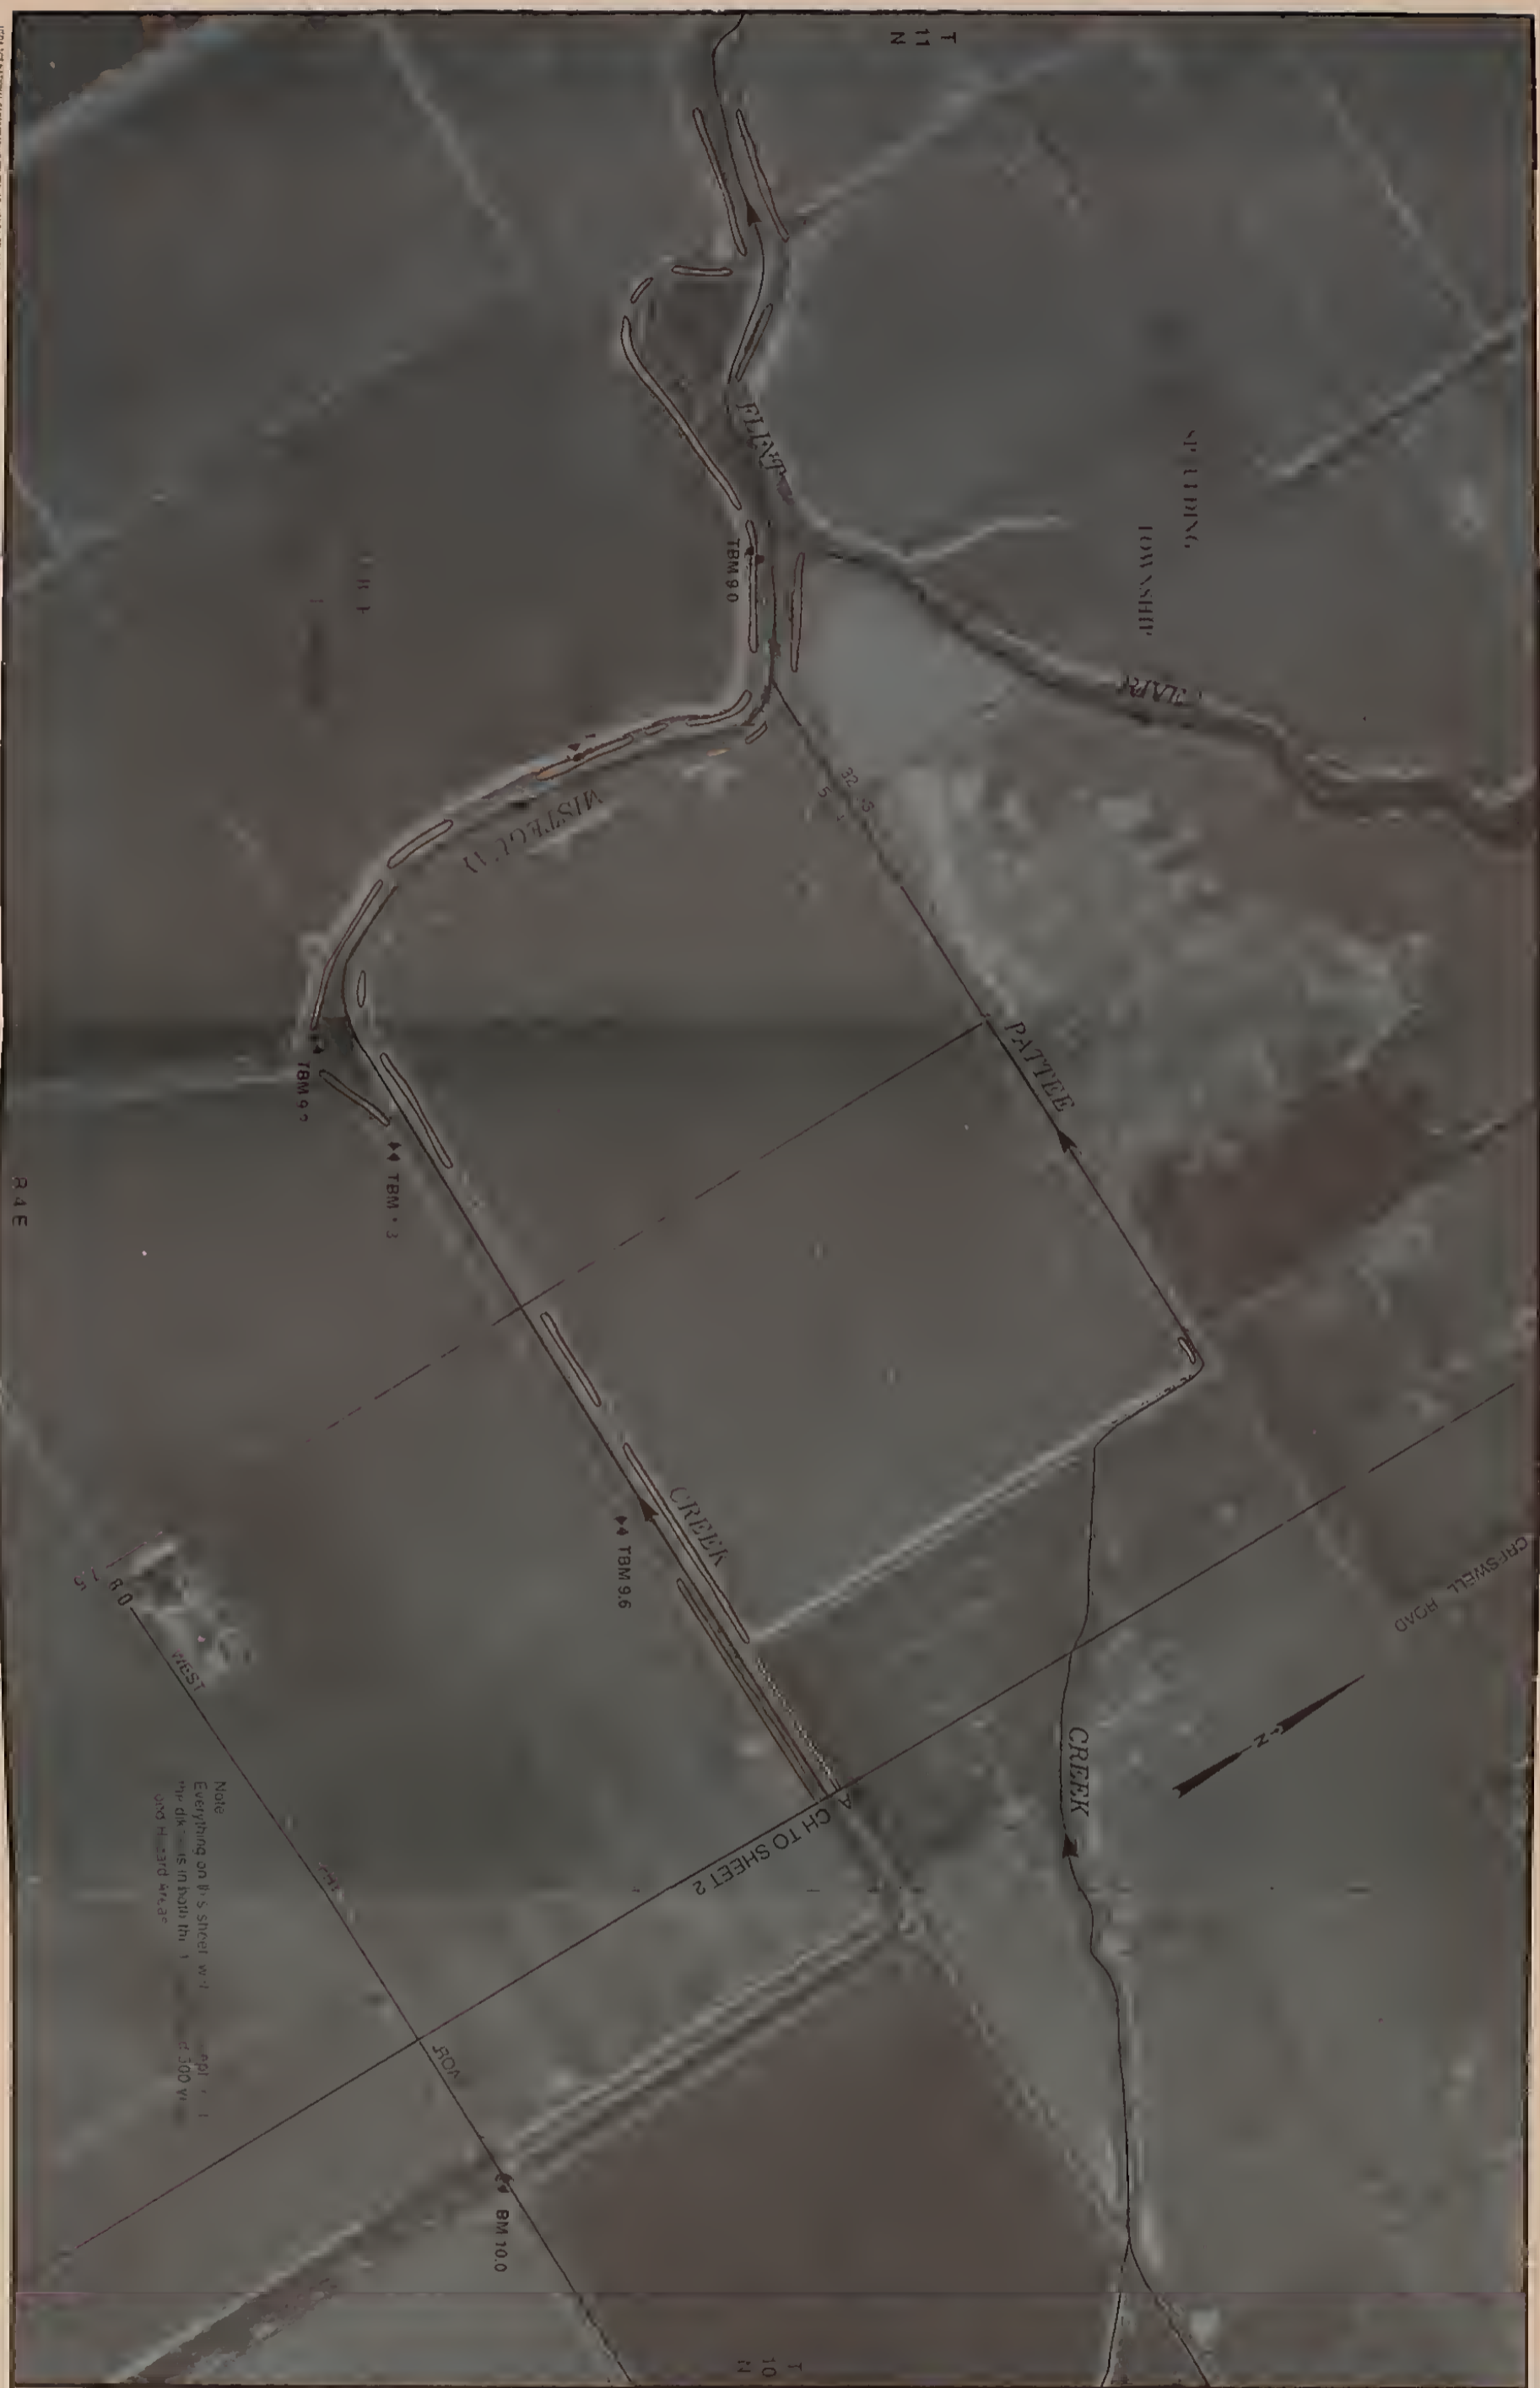
SHEET 1 OF 17

- 100 Year Flood Hazard Area
- 500 Year Flood Hazard Area
- 8.0 Valley Section Location
- Stream Channel
- Temporary Bench Mark

FLOOD HAZARD AREA

For those areas within the flood hazard boundaries, refer to the adjacent high water profile and locate the area of concern on the profile. The mean sea level flood elevation can then be determined for the appropriate flood event. Table 4 (Appendix C) shows flood elevations at each cross-section.

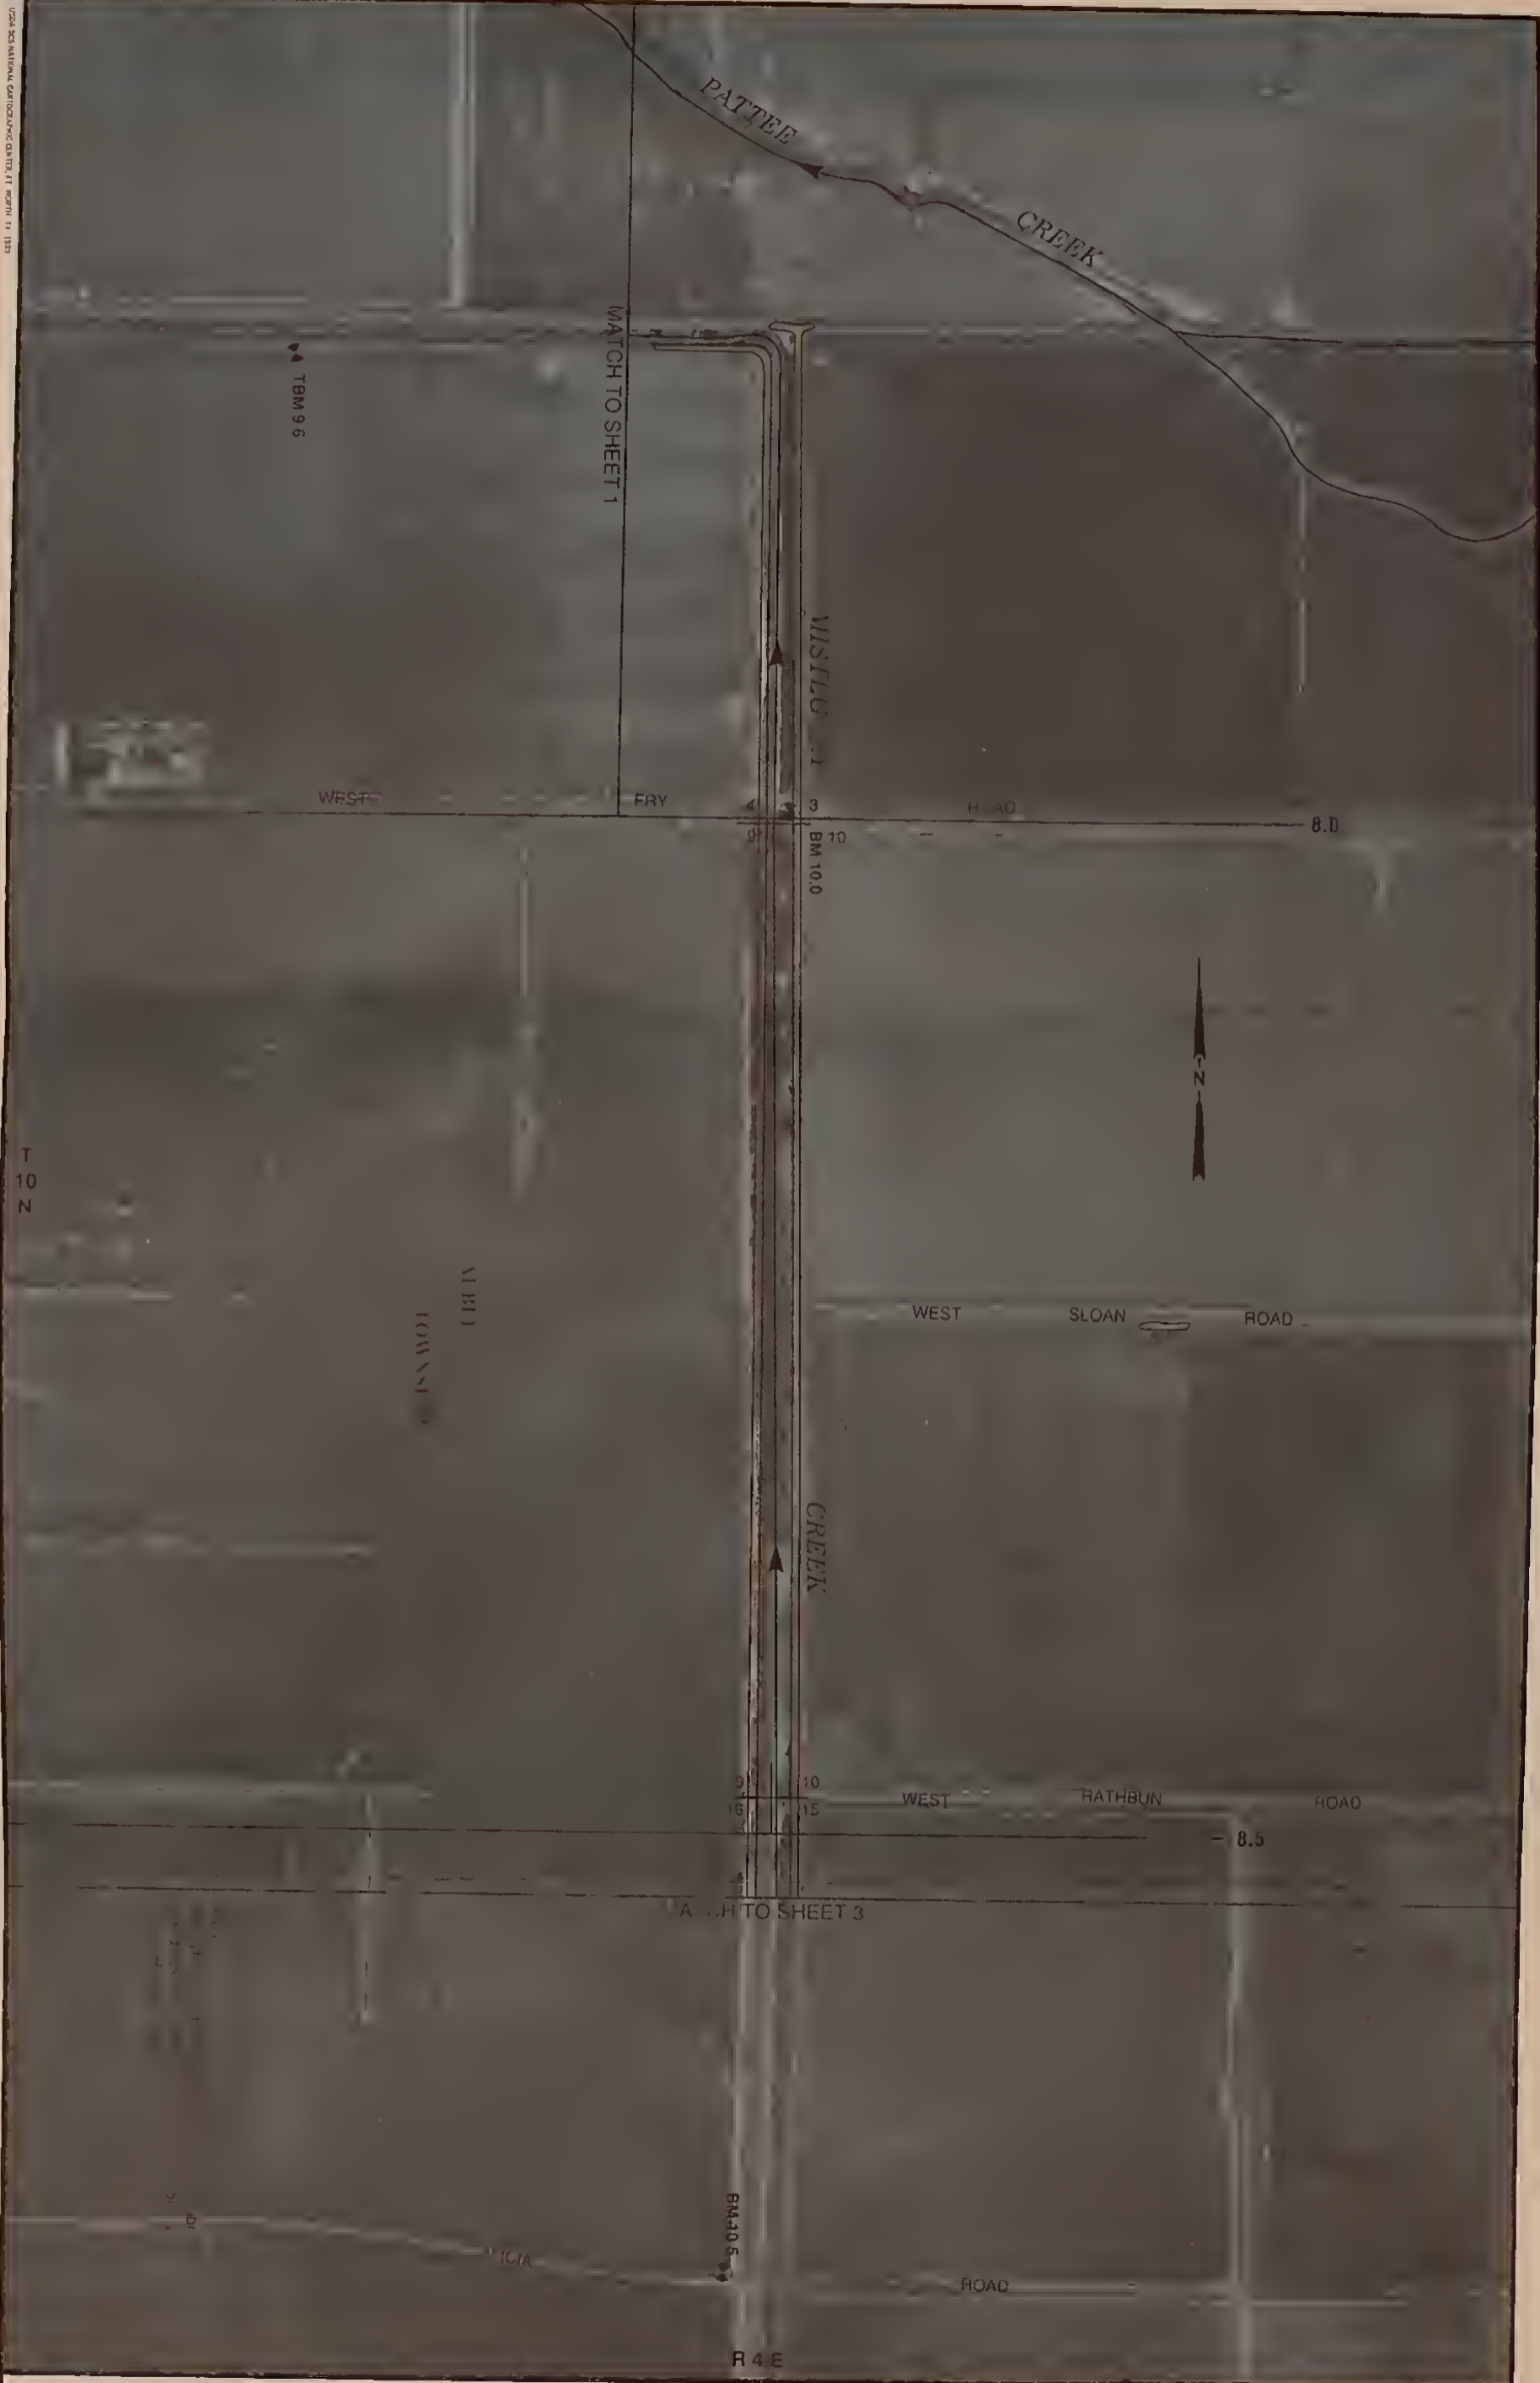
100 Year Flood Hazard Area

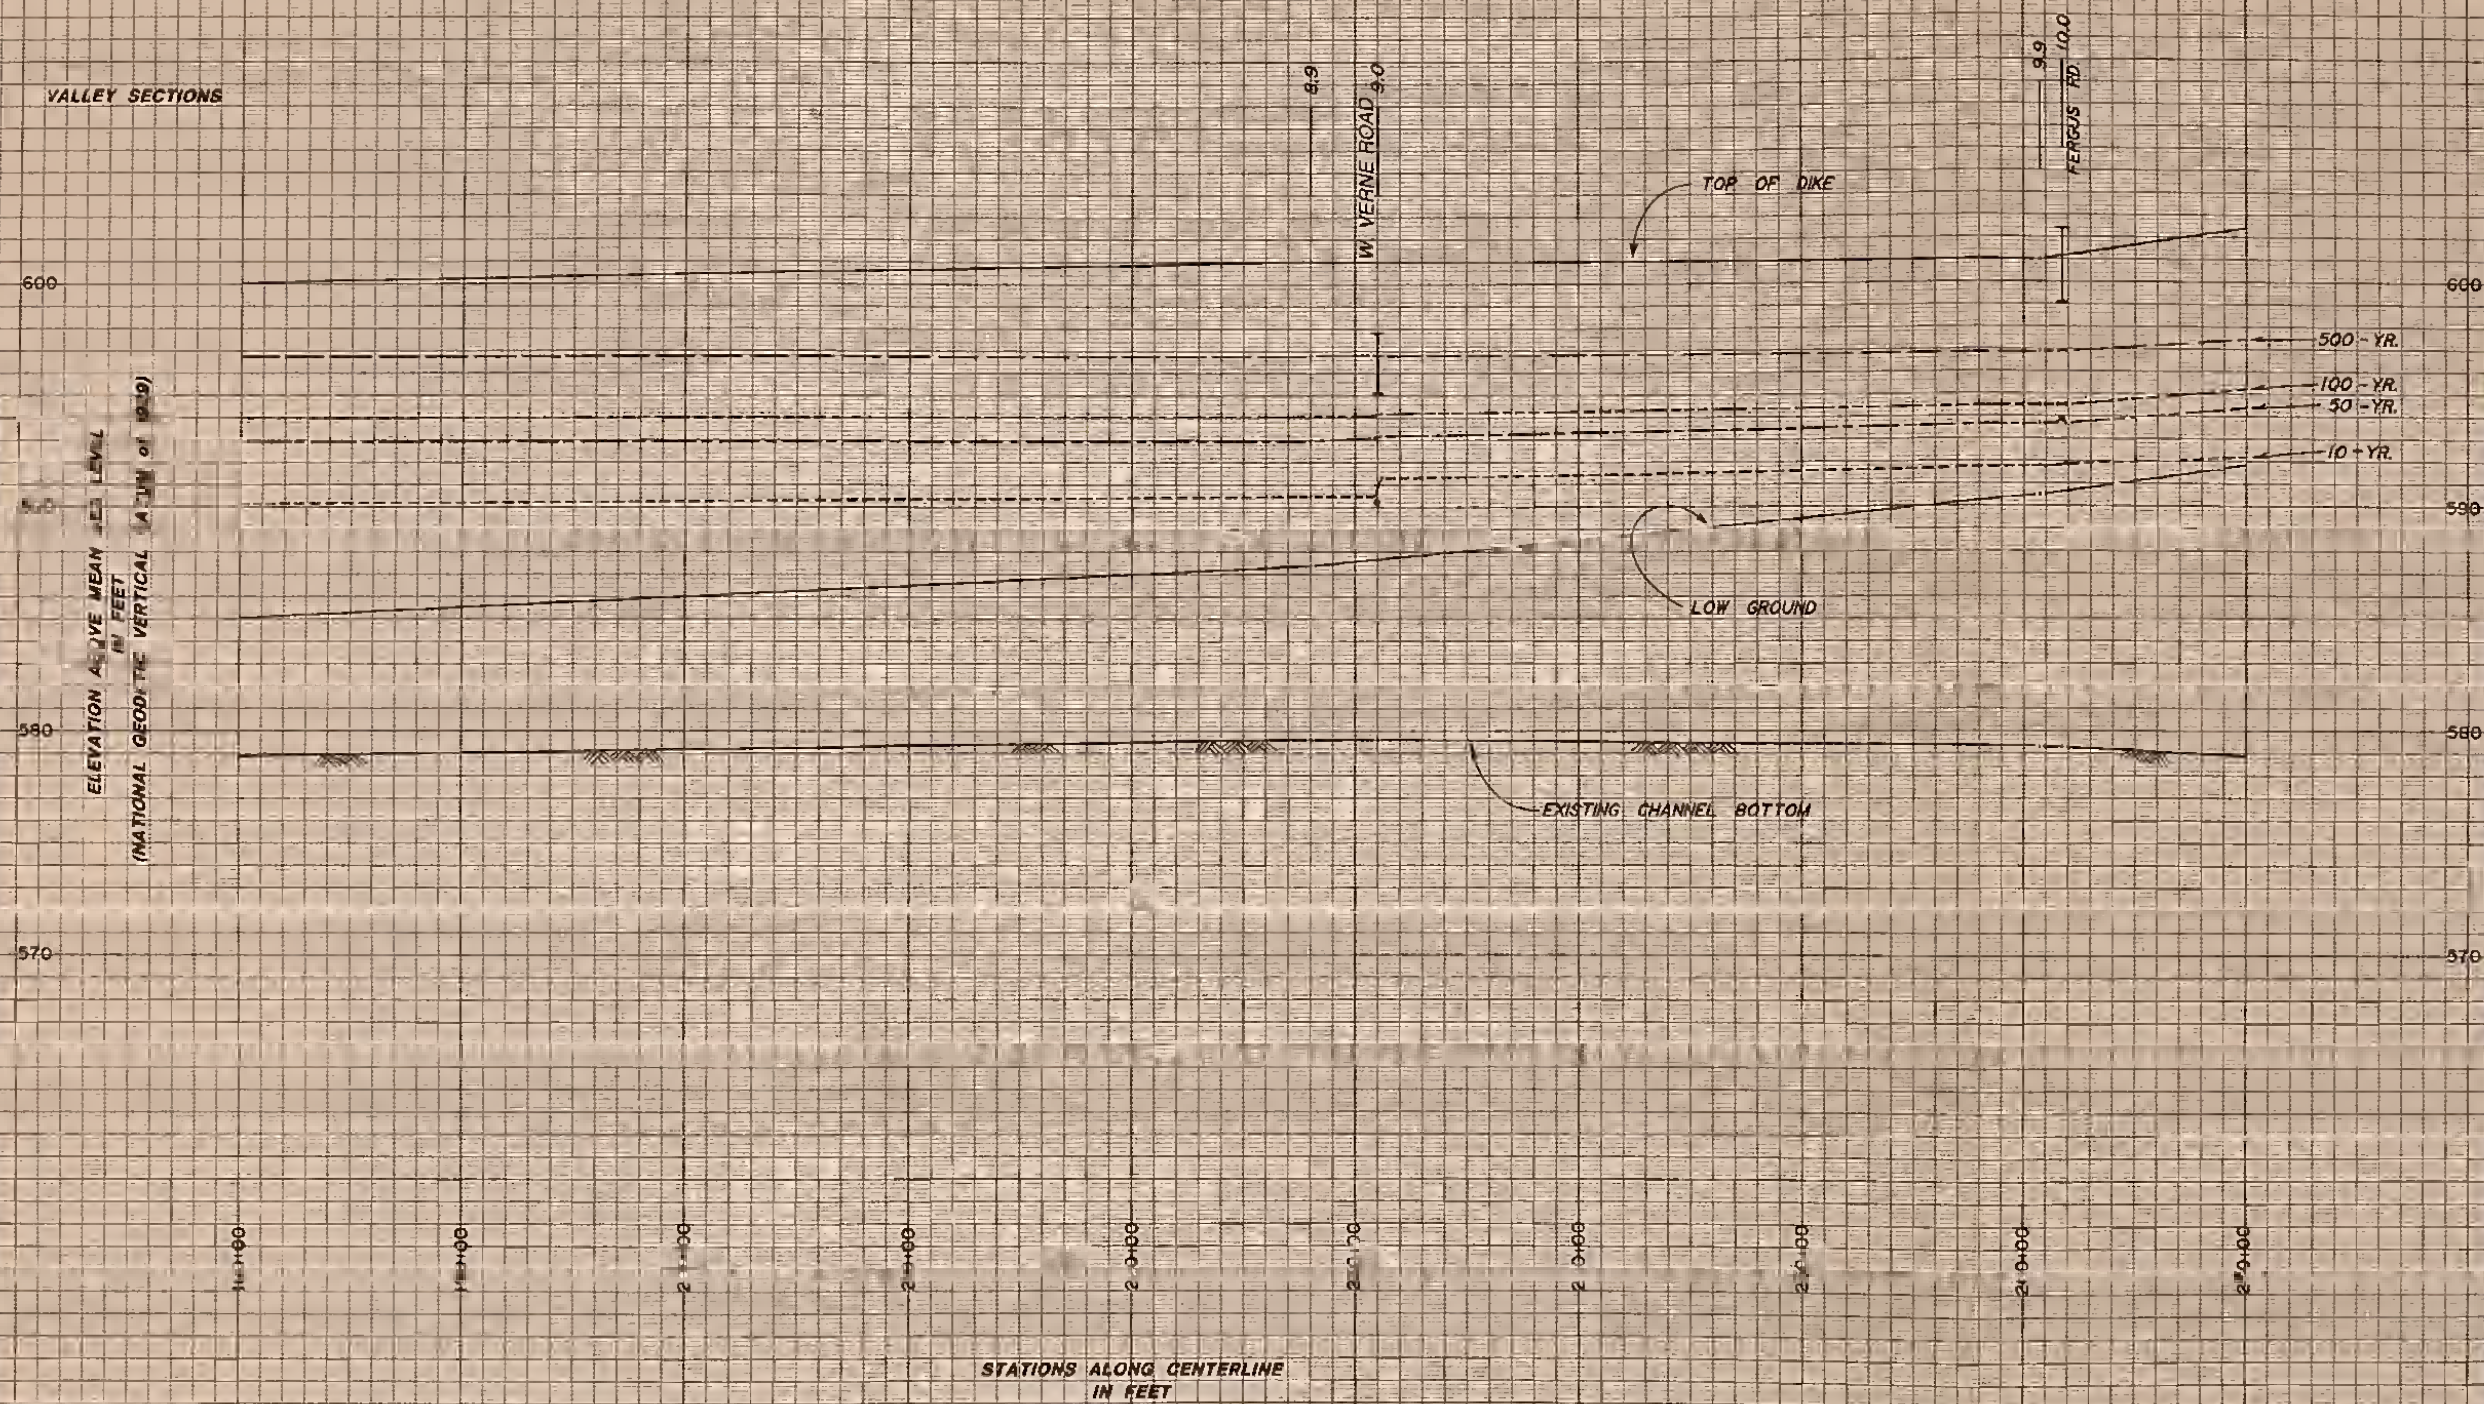
NOTE:
Additional field measured cross-sections may be needed to verify the water surface profile between the cross-sections used in this report. When the difference in the elevation of the channel bottom between cross-sections exceeds 2/3 the depth of flood flows, variations in the channel bottom can cause significant changes in the flood profiles.

HIGH WATER PROFILES
MISTEGUAY CREEK
FLOOD PLAIN MANAGEMENT STUDY
GENESEE, SAGINAW AND
SHIAWASSEE COUNTIES, MICHIGAN
U.S. DEPARTMENT OF AGRICULTURE
SOIL CONSERVATION SERVICE

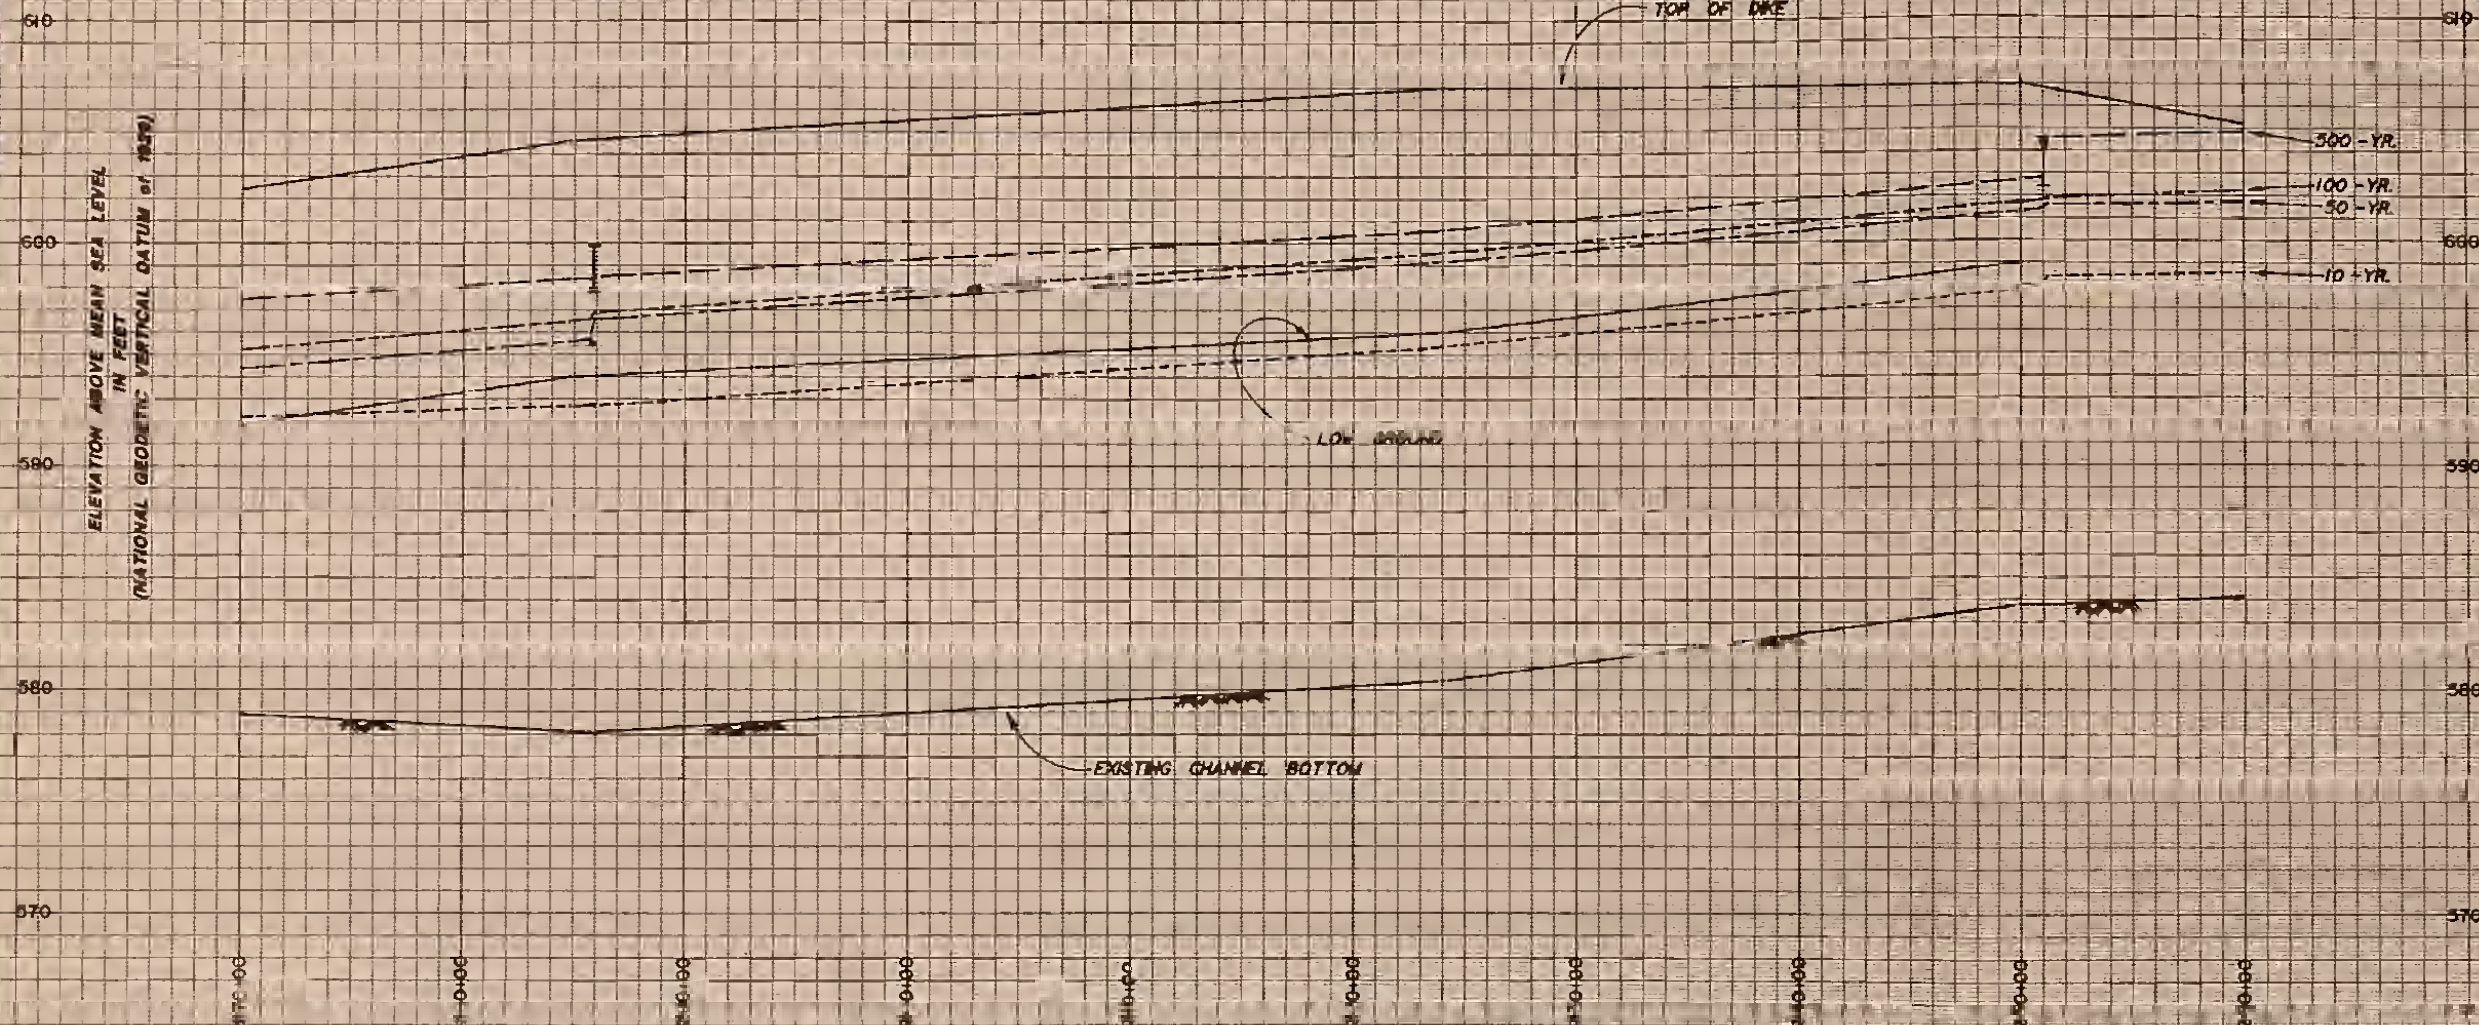
HIGH WATER PROFILES			
MISTEGUAY CREEK			
FLOOD PLAIN MANAGEMENT STUDY			
GENESEE, SAGINAW AND			
SNIWASSEE COUNTIES, MICHIGAN			
U.S. DEPARTMENT OF AGRICULTURE			
SOIL CONSERVATION SERVICE			
Designed T.D. BOURDON	Date 12-88	Approved by Title	
Drawn L.A. WILSON	Date 12-88	Title	
Traced		Sheet No. 4	Drawing No. of 17
Checked R.H. BAUERLE	Date 12-88
